Analytical Study Of Inclusivity In Design Of University Campuses In Lahore

Madiha Ghafoor¹, Muhammad Taimur Sarwar², Saira Naeem³, Rabia Ahmad Qureshi⁴

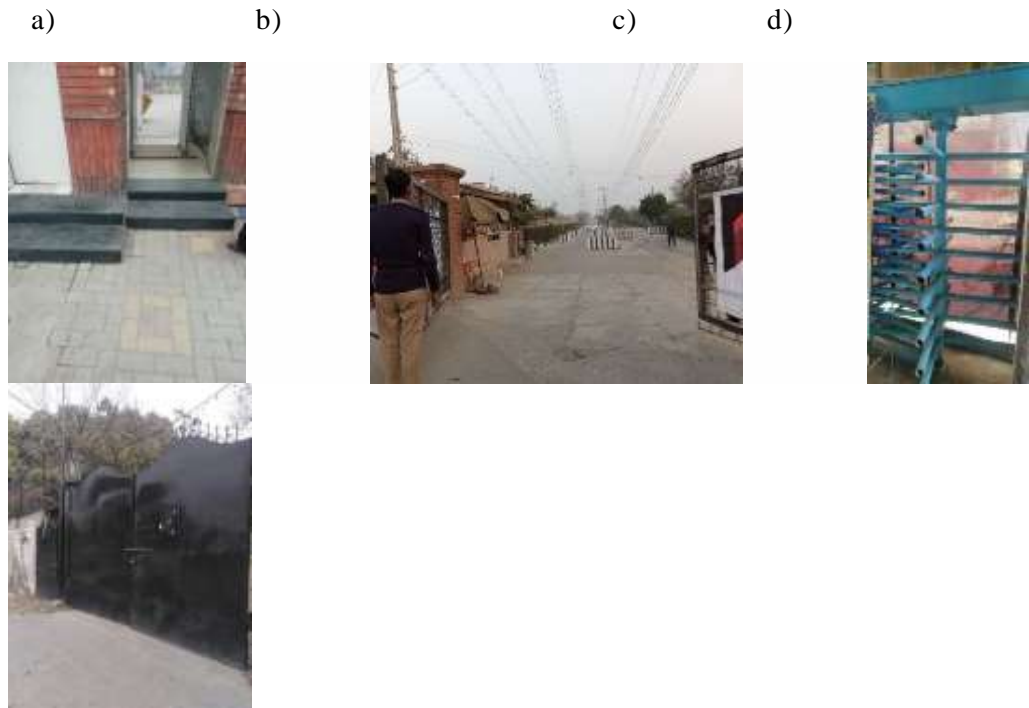
The grading of selected universities with reference to the assessment tool indicates that none of these had designated accessible parking spaces with proper signage and line markings. The only pedestrian entrance in UET has a raised entrance foyer and requires use of multiple steps to enter and exit from it. The steps are finished with polished granite and become slippery after rain. The threshold of the door is 4 ½" high and is unbeveled. The main approach point for the COMSATS campus consists of a shared entrance for both vehicles and pedestrians with no segregation of routes. All of these campuses has separated parking lots for students and staff. The parking lots for staff are in close proximity to buildings so the students with special needs are also allowed to use these parking spaces. However, none of these spaces is marked as accessible parking spots and no designated accessible route connects them to adjoining buildings. The students' parking lot in UMT is just an unpaved plot across the road with no line markings which becomes quite messy and slippery in rainy weathers. The pedestrian approach points for students in UMT, consist of a series of revolving door lined along boundary walls that cause hindrance for all users who are facing any form of mobility restriction or carrying luggage, hence, they are forced to use the adjacent staff entrance gate. The pedestrian entrance of Punjab University that is in close proximity to the selected building is aligned with road level and does not involve use of any stairs.

Figure 1. (a) Raised floor of pedestrian entranceway at UET, (b) Common entrance gate and passage for vehicles and pedestrians at COMSATS, (c) Revolving doors of students' entrance at UMT (d) Pedestrian entrance gate

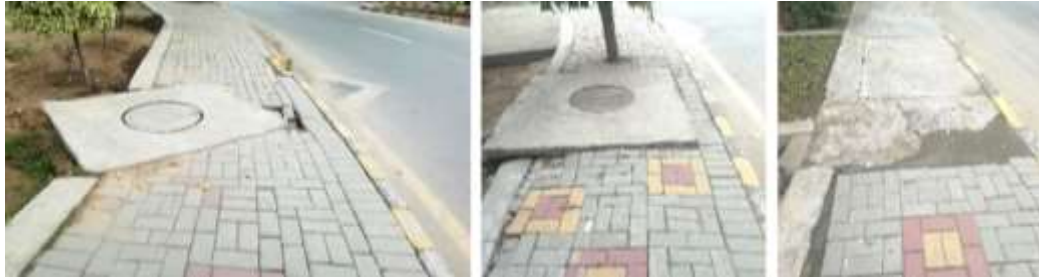
There is no specified accessible route to access various facilities in all the selected campuses so the routes connecting the selected building to parking lots and campus approach point were selected for this study. The routes are paved and finished with concrete pavers which can provide quite stable and slip resistant surface if properly installed. However, in UET and PU, the surface is quite uneven at several points along the route. The pavers have been misaligned due to uneven settlement of soil and penetration of tree roots beneath them. The manholes are also not aligned with the walkway surface.

Figure 2. Uneven surface due to misalignment of paver can cause tripping or imbalance of wheelchair

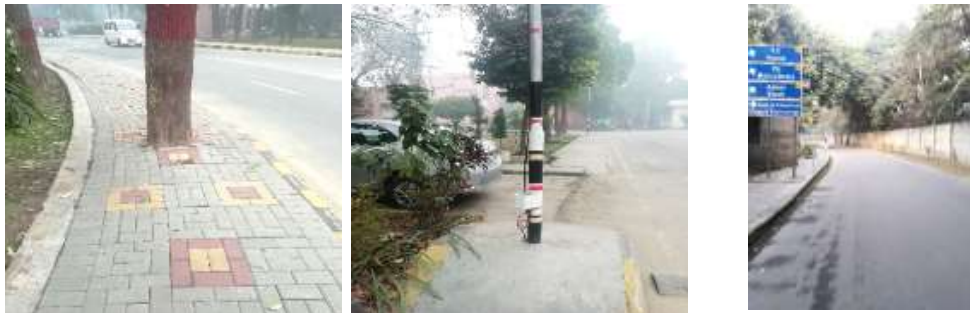
Figure 3. Trees and poles and signboards obstructing the route in UET and PU

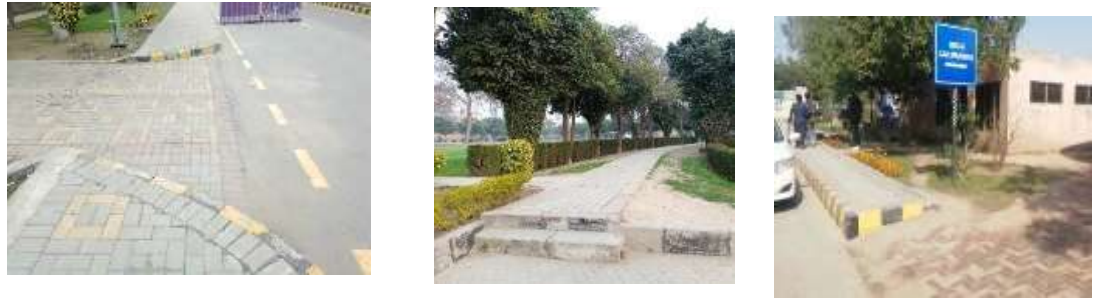
d) Figure 4 Absence of standard curb ramps

a) Absence of curb ramp at crossing in UET

b) Absence of curb ramp at the rout connecting parking to buildings in COMSATS

c) Semi-paved crossing without curb ramp in UMT

d) Steep gradient and uneven surface of ramp in PU

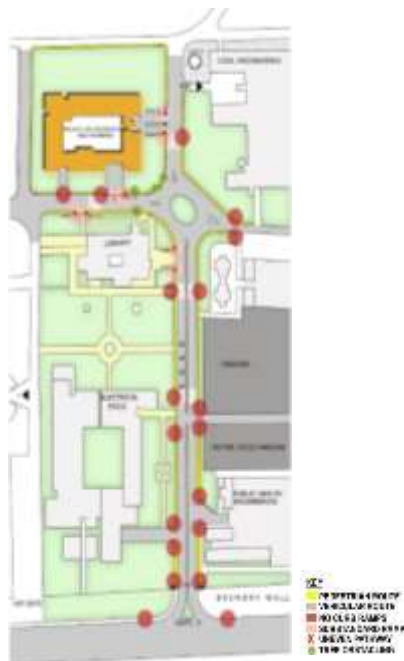
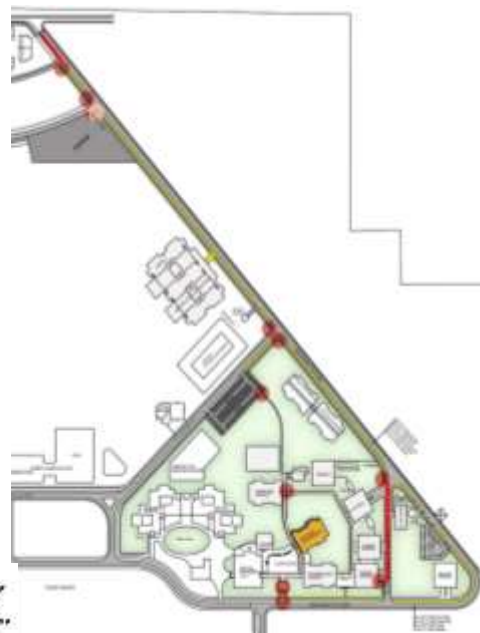
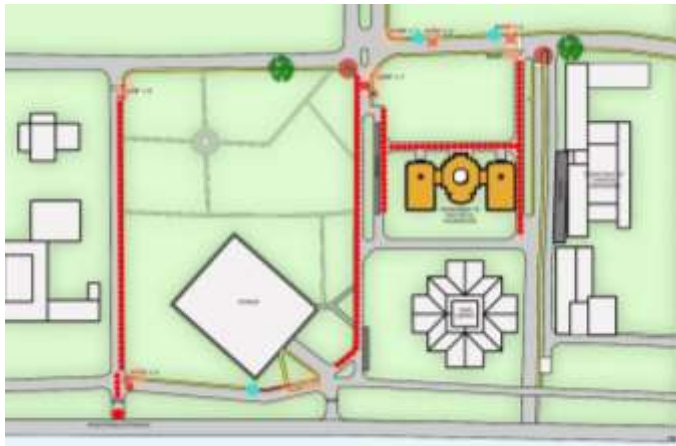
Figure 5. Barrier mapping of the selected exterior route of the universities, (a) UET, (b) COMSATS, (c) UMT, (d) PU

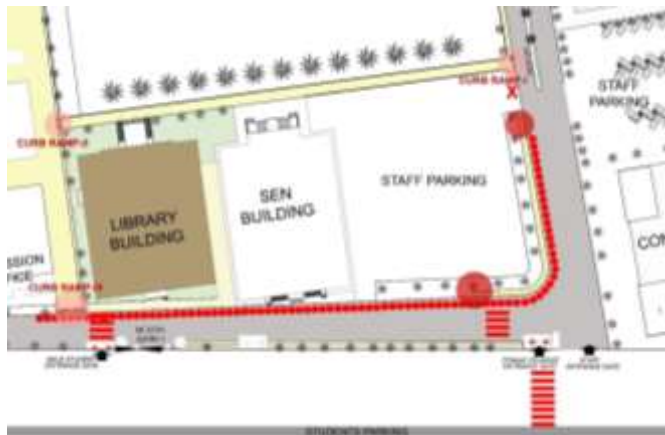
All of the selected buildings, other than PU, was provided with any form of accessible entrance. In UET, out of two primary entrances one was provided with ramp and a secondary entrance to Dept. of Architecture was also used as an accessible entrance. In Punjab university and UMT, the primary entrances were accessible to users with different needs, however the gradient of ramps was not as per acceptable standards. All the entrance doors are adequately wide but in UMT the threshold of the main entryway has a change of level of around 1 inch that is not beveled. The doors remain open during working hours of the department so the hardware details do not affect the accessibility of users. None of the two entrances of selected building in COMSATS had any consideration to accessibility.

Figure 6. Details of accessible entrance

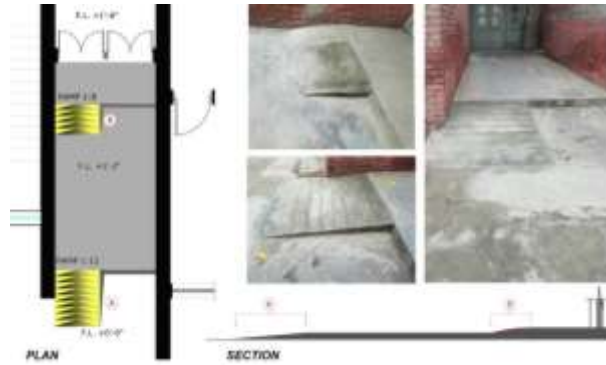
Figure 7. Raised thres hold of accessible entrance way

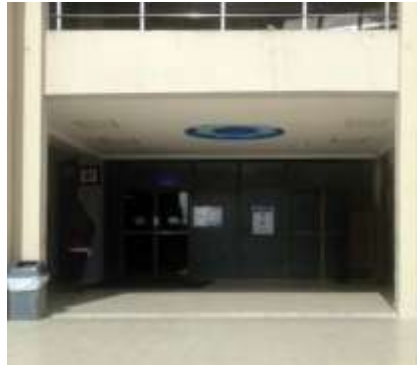
Figure 8. Inaccessible entrance COMSATS university

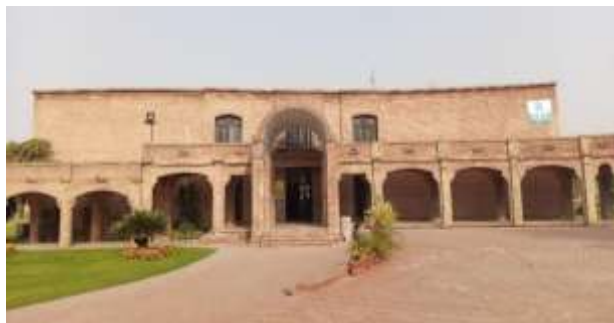
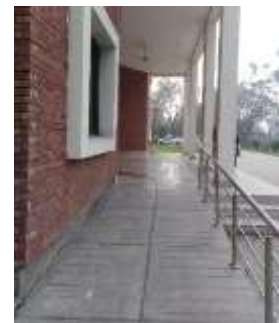
Figure 9. Handrail and surface treatment of ramp

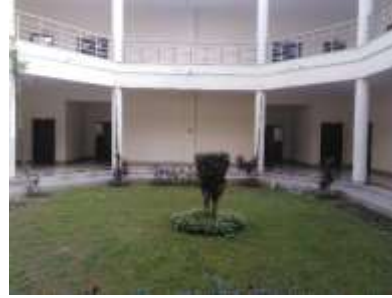
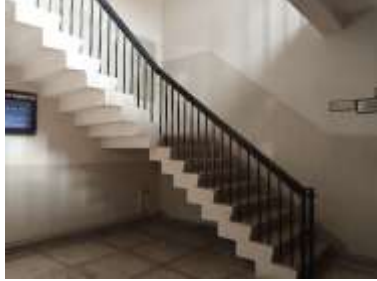
Figure 10. Inaccessible jury hall in UET,

Figure 11. Central Inaccessible courtyard in PU,

Figure 12. Staircase in Electrical Engg. Dept. COMSATS without slip resistant strip

Vertical circulation is one of the most crucial problems in most of the studied buildings. Other than UMT, none of the building has any provision of elevator or access ramp reaching to the upper levels which makes all the upper floor levels completely inaccessible for diverse users. Staircases in all buildings are not provided with an anti-slip strip.

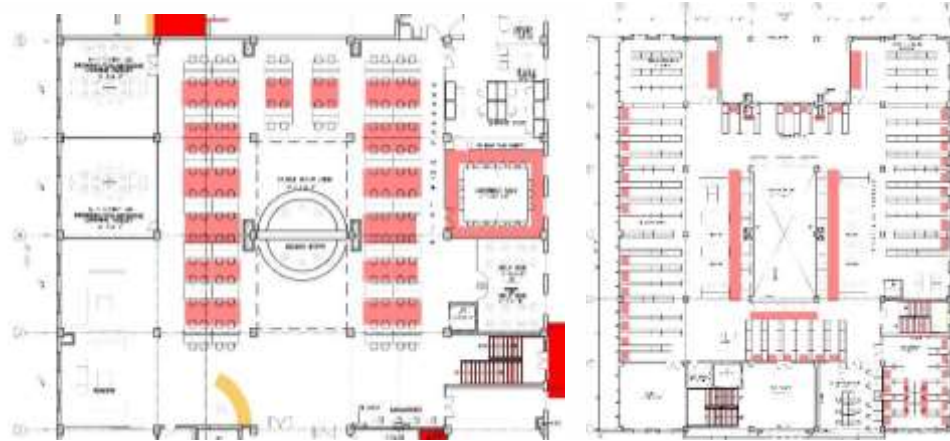
The libraries in UMT and PU are quite spacious but the bookshelves aligned with wall terminate at dead ends only 30 inches wide instead of 60 inches that cause trouble for users in wheelchair in making 180 degree turns. Similarly, the tables are closely spaced with less than 36 inches space between chairs. The rest of the interior spaces in all sample buildings have moveable furniture layout that can be rearranged according to the requirements.

Figure 15. Floor plans of library showing insufficient manoeuvring turning clearances

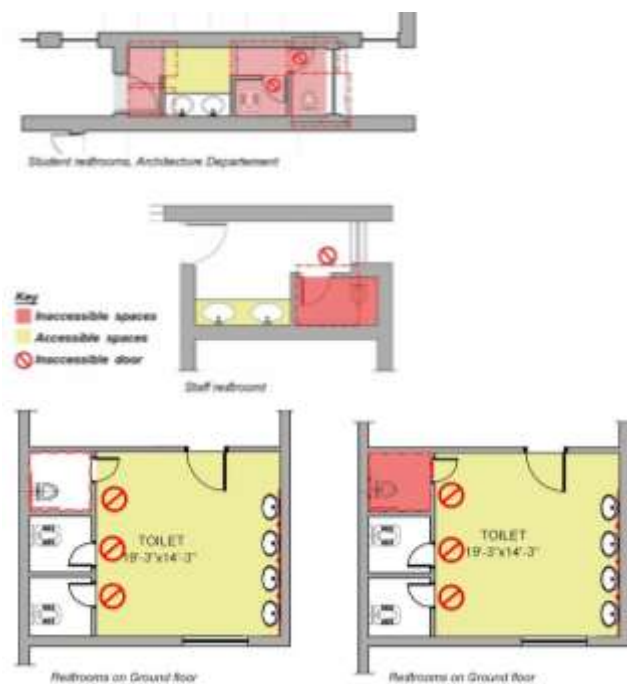
None of the selected facility has designated accessible toilets so public toilets were studied for this research. In UET, the layout of the toilets is too congested for wheelchairs to maneuver in. There is not enough clearance space between the door and the privacy wall. The internal circulation aisles are 2'-3" wide in spite of standard 3'-0". The mirror is provided over the lavatory at a height of 50 inches that cannot be used by people using wheelchairs but a full-length mirror provided that can accommodate all users. The lavatories fulfill the standard requirements of approach, height, knee and toe clearance. The pipes below the vanity are not concealed and can be unhygienic if they get in contact with legs of wheelchair users. Water closets are located in separate stalls

that are too congested with narrow entrance doors is 24 inches to accommodate wheelchairs.

The layout of toilets in COMSATS is quite spacious for easy manoeuvring of a wheelchair. One stall in each toilet facility has an outward opening door that enables wheelchair clearances and turning space within the stall. The width of stall entrance doors is 24 inches that is quite less than the standard 32 inches. The floor level of stalls in first floor toilets is 2 inches lower than rest of the floor and is not bevelled or provided with slope. The mirror is provided over the lavatory and the soap dispenser are mounted higher than approachable height. The lavatories fulfil the standard requirements of approach, height, and toe clearance but the knee clearance gets interrupted by the washbasin.

Figure 15. Plans of toilet blocks showing level of accessibility

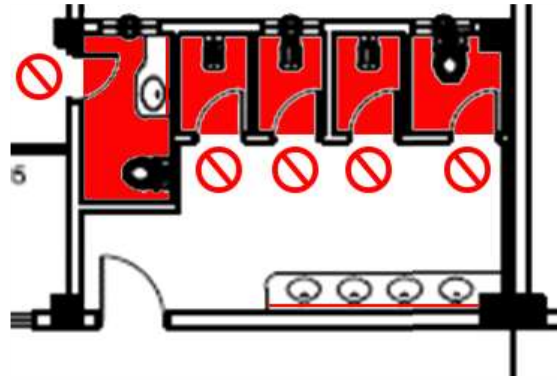
The toilets in UMT are quite spacious and has standard space to reach lavatories, hand dryer and towel rail. A four inches high ledge provided under the lavatory shelf restricts the approach by blocking knee and toe clearance. The faucets are easy to operate and can be used with just one hand but are difficult to access because of floor ledge blocking the clearance space.

Water closets are located in separate stalls that are too congested to accommodate wheelchairs. The doors open inwards and internal stall space is insufficient for the wheelchairs to take 180 degree turns after entering the stall. The width of stall entrance doors is 24 inches that is quite less than the standard 32 inches. There are no grab bars provided in any stall to assist weakened, disabled, or elderly individuals safely access the facilities.

Figure 16. Plan of toilet blocks highlighting all accessibility barriers (a) UMT, (b) PU

In PU, the entrance doors are adequately wide and the lavatories areas have spacious manoeuvring clearances for wheelchairs. The lavatories have a vertical standing post that blocks the knee clearance. As the depth of lavatories is 18 inches so faucets can be easily accessed and operated. The soap dispensers are mounted over vanities on an accessible height. Mirrors mounted higher than 40 inches can also not be used by wheelchair users.

None of the student restrooms and only one faculty restroom has adequate turning clearance. No grab bars have been provided in any restroom. The doors to water closet stalls are less than 32 inches. The locks of these doors are mounted at the top of doors making them inaccessible for diverse users.

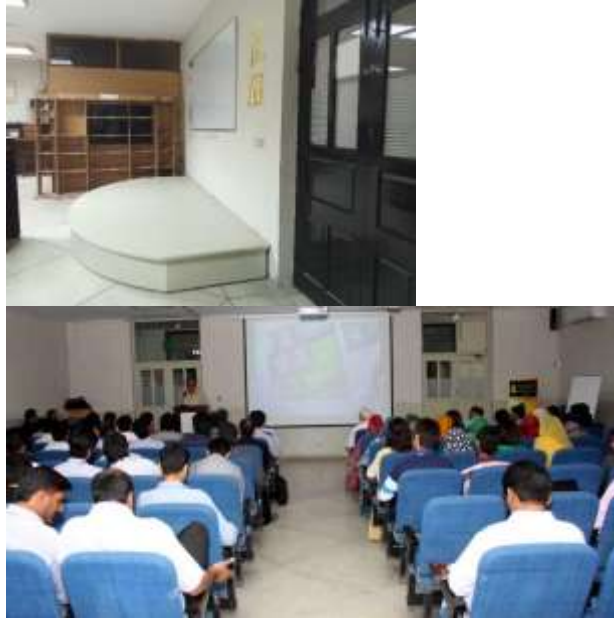
In COMSATS, one of the labs has a 12 inches raised platform acting as a stage with no steps or ramps provided for access. This might impede elderly and mobility impaired people from fully participating in class presentations and lecture activities. The seating arrangement in one room consists of movable chairs so the wheelchair can easily be accommodated in group, however, the seating in other lecture rooms consists of fixed rows of chairs with narrow circulation aisle, and no provision of wheelchairs. Most of the rooms comprise of labs with adequate circulation spaces to access each workstation. Only one lab has workstations with two different heights. Other than this, no consideration has been given to provide a variety of working heights or flexible heights.

Figure 17. Raised platform in lab

Figure 18. Fixed seating arrangement

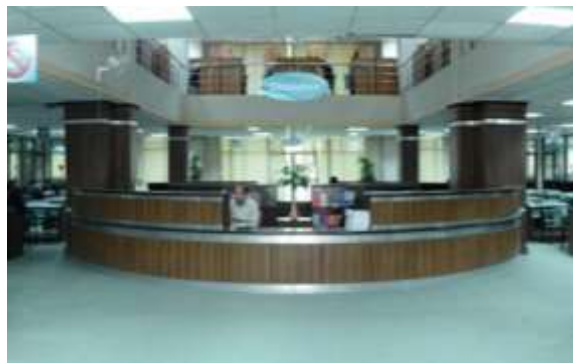
The ground floor of the building in UMT consists of library. The central reception and issuing booth of the library is well designed with different heights that can accommodate diverse users. The length of these sections is also more than 36 inches with clear floor space for parallel approach. The waiting space and reading lounge in the library are spacious enough to accommodate a wheelchair sitting along with other sitting spaces without obstructing the circulation path. The circulation space between reading tables of the library is not adequate for wheelchair manoeuvring. A few power plugs in classrooms are provided at 12 inches from floor level but the availability of other plugs and switch boards at 42 inches height in the same room creates balance between different ranges of access for different users.

Figure 19. Accessible portion in main reception of library

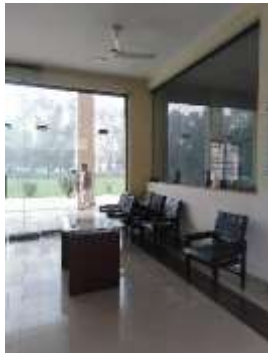
a)

The main reception counter in PU has been cordoned off by glass panel and has an inaccessible height. The counter in the library, on the other hand, has accessible height with provision to knee and toe clearance. The lecture rooms has auditorium style seating in which only lowermost level is accessible but the first row of tables is aligned over first step which makes the seating in lecture rooms inaccessible. The working counters in all labs are provided along the wall with wide central clearance space to approach each counter. The cabinet under these counters block the knee and toe clearance of users.

Figure 20. Inaccessible services at PU

(a) main reception (b) Seating in lecture rooms (c) No knee and toe clearance in working counters of lab

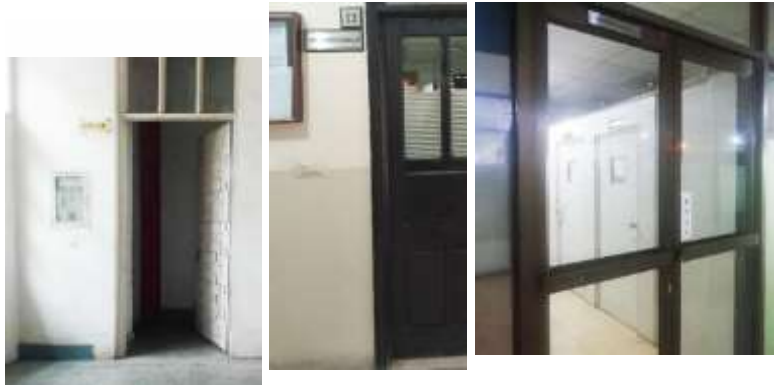
The signage has been provided at a few points throughout the campuses to guide the users towards important buildings and facilities within the campus. The signage in campus, outside the building, provides directional information about important buildings. Within the buildings the sign boards are provided designating the important rooms and spaces none to provide directional information and assist in wayfinding. A reception desk has been provided only in Punjab University to guide the visitors about the facility. There exists a color contrast between characters and background to make them more prominent. The use of glass and stainless steel base plates in COMSATS and UMT causes severe glare of light from nearby light fixtures. The information about fire safety and emergency evacuation contains pictograms along with texts in COMSATS and PU.

Figure 21. Signage provided at inappropriate height
